TIER 1 EELGRASS DELINEATION REPORT

Juneau Douglas North Crossing PEL Study

1138.63234.01

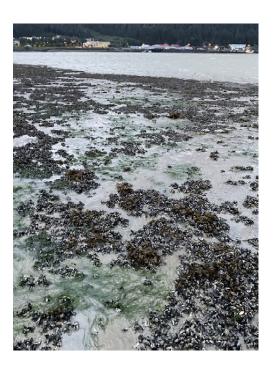
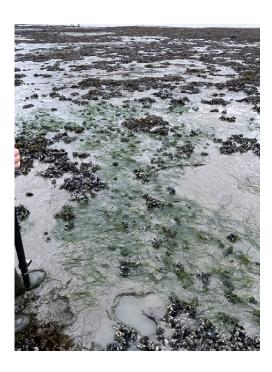
Photo Set 1: Location on south end of the proposed Salmon Creek Alignment

Only one location documented "dwarf" eelgrass *Zostera japonica* outside the study area (approximately 25 feet) on the south side of the Salmon Creek alternative (Table 3, Photo Set 1, and Figure 2).

Note: Left photo view is oriented toward the northeast across the Eelgrass bed, and right photo view is oriented down on the Eelgrass bed

The National Oceanic and Atmospheric Administration Alaska ShoreZone Mapping (NOAA, 2023) has mapped patchy eelgrass on the south shore within the Salmon Creek alignment. No eelgrass was previously identified at any of the alignments between 2004 and 2011 (Harris et al., 2008, Harris et al., 2012). Based on these previous surveys and the survey conducted in 2023, the proposed alignments are absent the presence of eelgrass. However, the proposed Salmon Creek alignment is adjacent to a patchy eelgrass bed. Changes in the project may require additional eelgrass survey on the southside of the proposed Salmon Creek alignment.

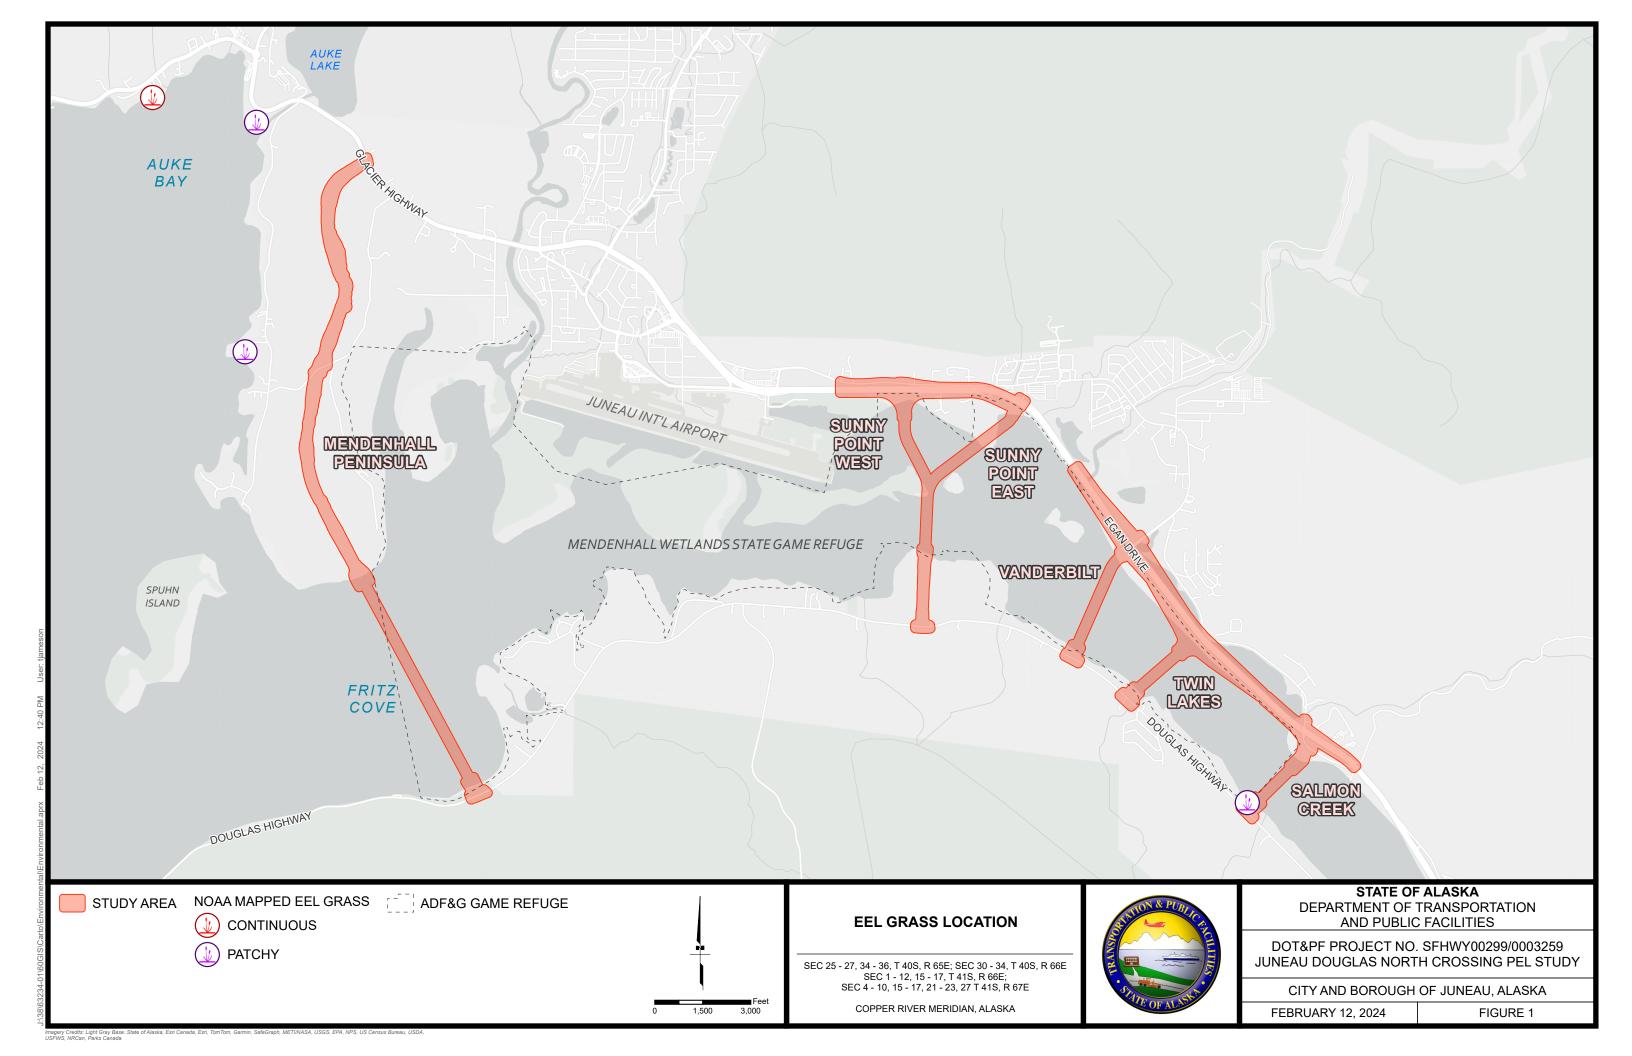
The study area is within six potential crossing alignments: Mendenhall Peninsula, Sunny Point West, Sunny Point East, Vanderbilt, Twin Lakes, and Salmon Creek. The study area encompasses a 150-foot buffer zone for each of six potential proposed bridge alignments across Gastineau Channel (Figure 1).

Biological mapping units were acquired from the National Oceanic and Atmospheric Administration National Marine Fisheries Service's ShoreZone website. Patchy eelgrass is mapped on the south shore of the Salmon Creek crossing (Figure 1).
